# Wyoming Law Enforcement Academy

## Condition & Recommendation Report - 2023

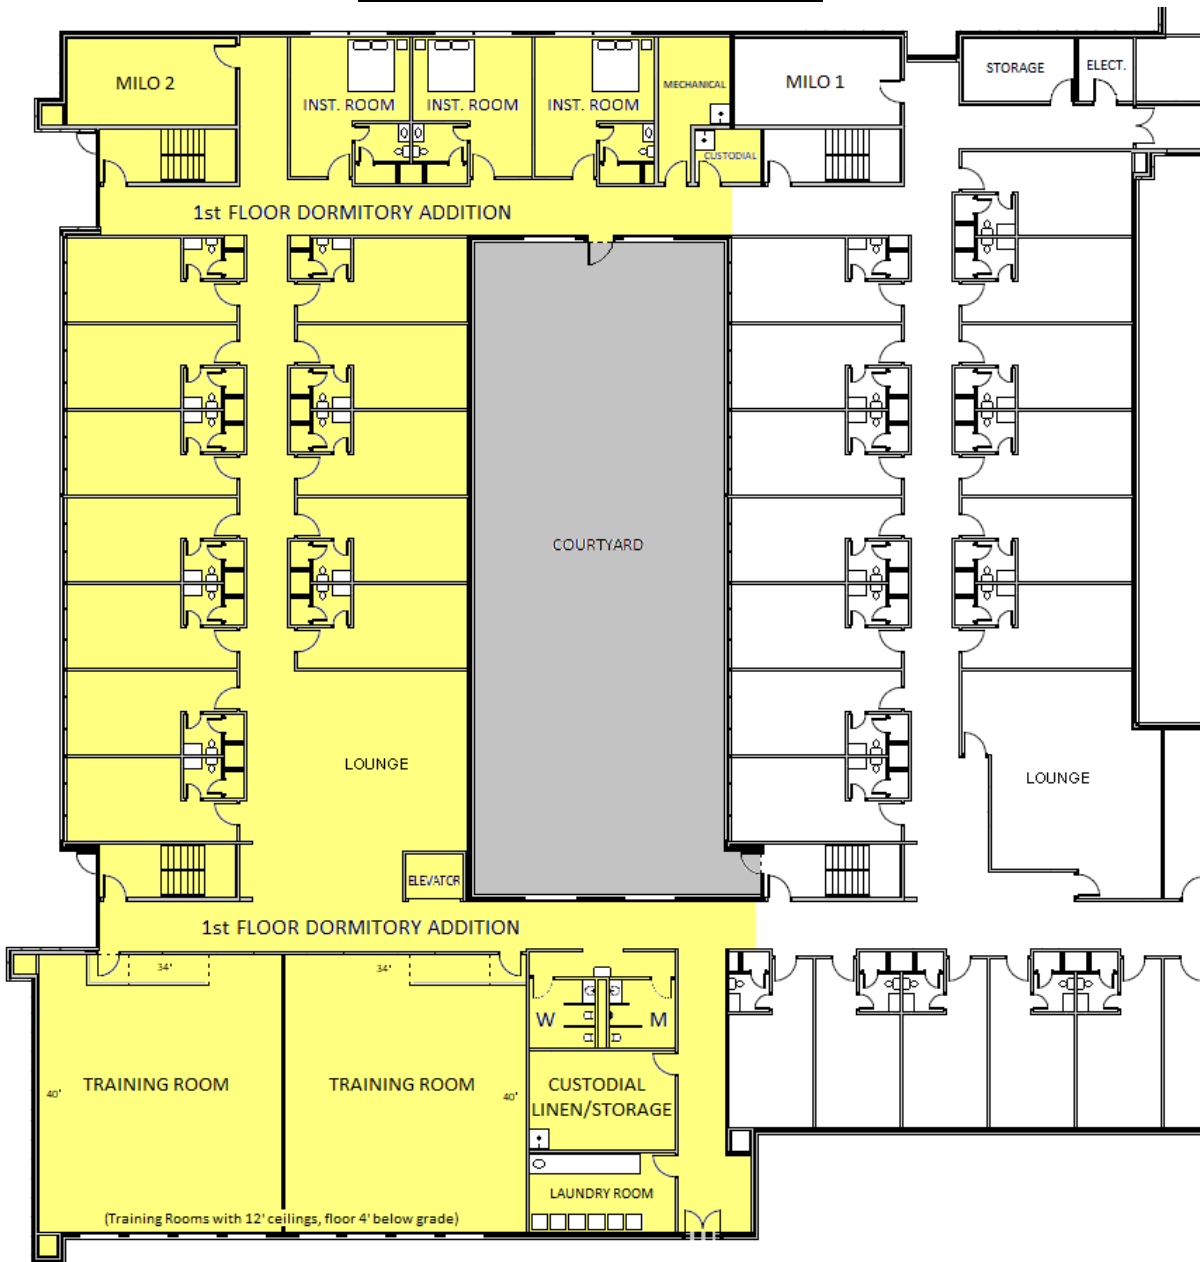
**DORMITORY ADDITION (FIRST FLOOR)**

We believe an additional dormitory, additional parking lot, and several large training rooms will help us meet the current training needs, and sustain the likely continued growth in the future. This dormitory would set parallel to our west dormitory and connect on both ends. It would mimic the existing dorm; 24 dorm rooms would be added, two training simulator rooms, two lounges, mechanical and custodial rooms, large student laundry, as well as 5 instructor/handicap rooms. It would increase our total bed count from 112 to 165. An elevator would be added to accommodate handicap guests, and assist our support services staff who are regularly moving supplies and equipment up and down floors (via stairs). On the south end of the new addition we would have one large conference room (40' X 80' with 14' ceiling) which could be divided in half to make two large training rooms. On the main floor there would be two medium sized training rooms (35' X 40' each with 12' ceilings). Public restrooms would be located just outside these training rooms on both floors.

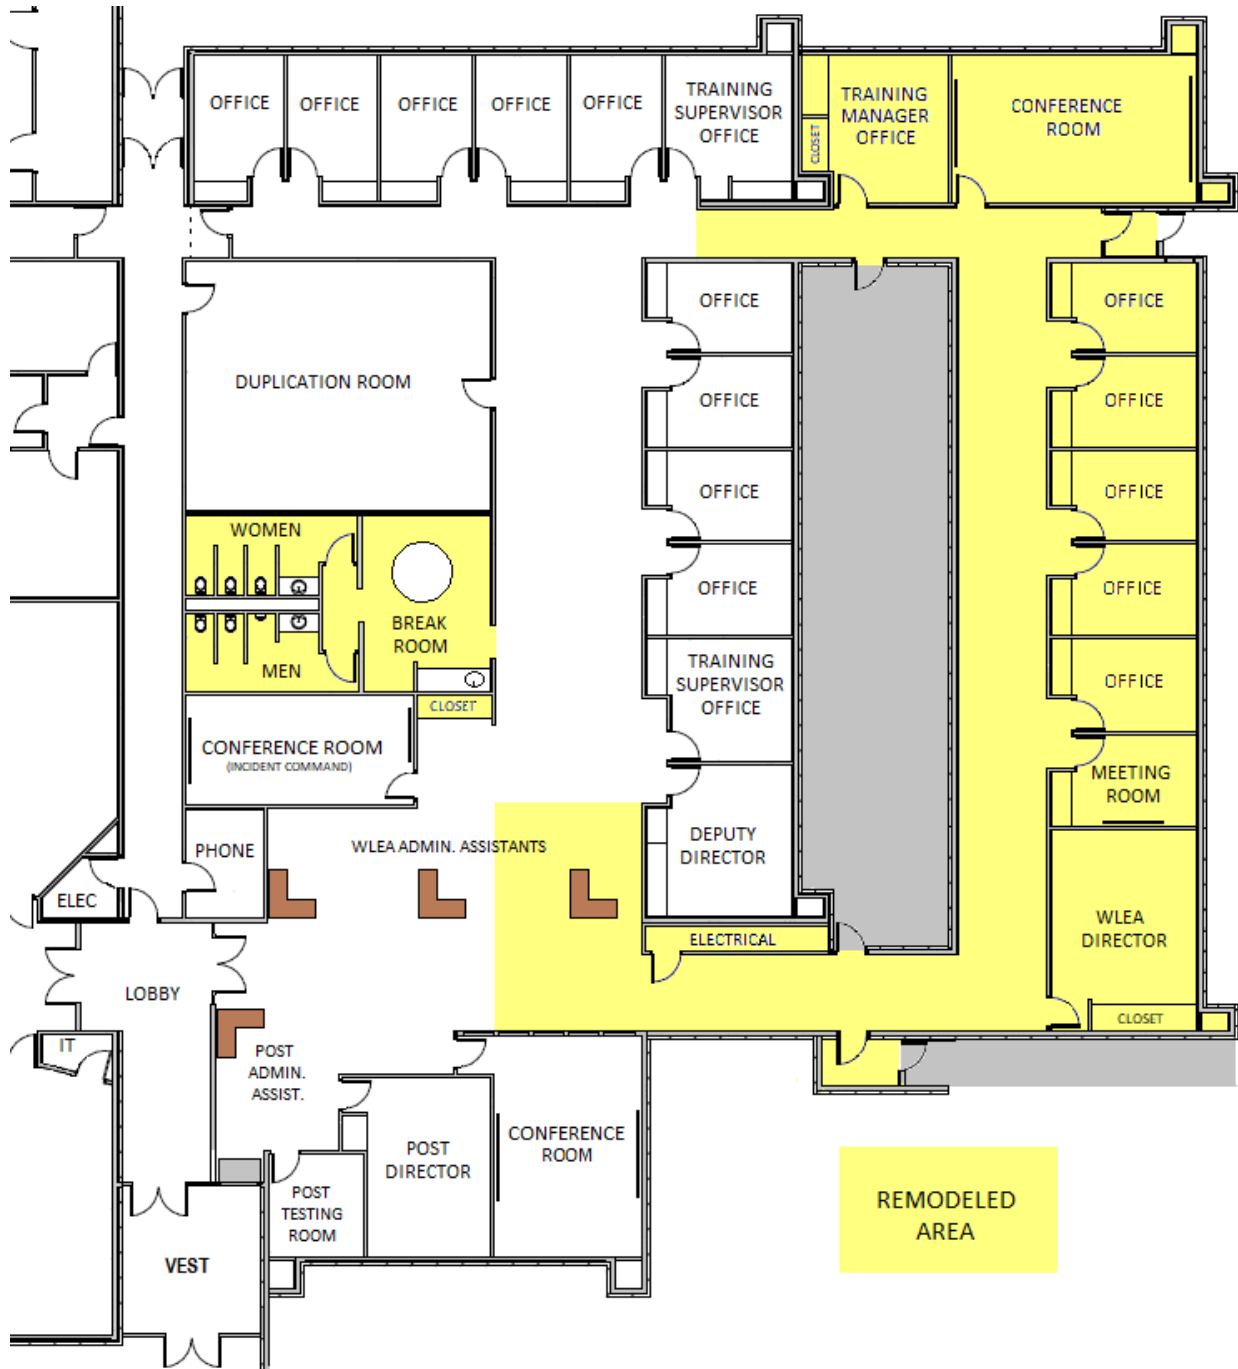
**PROPOSED ADMINISTRATIVE OFFICES**

Having an expanded capacity will allow us to continue to meet the training demands of the State, both Basic and Advanced. Having facilities that will accommodate larger classes and additional courses equates to greater workload on our staff, requiring additional training and support personnel. To further meet these demands, we are proposing an additional administrative wing attached to the existing floorplan to provide space for administrative support personnel and increase the size of the restrooms in the admin area. Seven offices would be included in the new wing, as well as a meeting room/office and large conference room. (See original blueprint, then proposed design below)

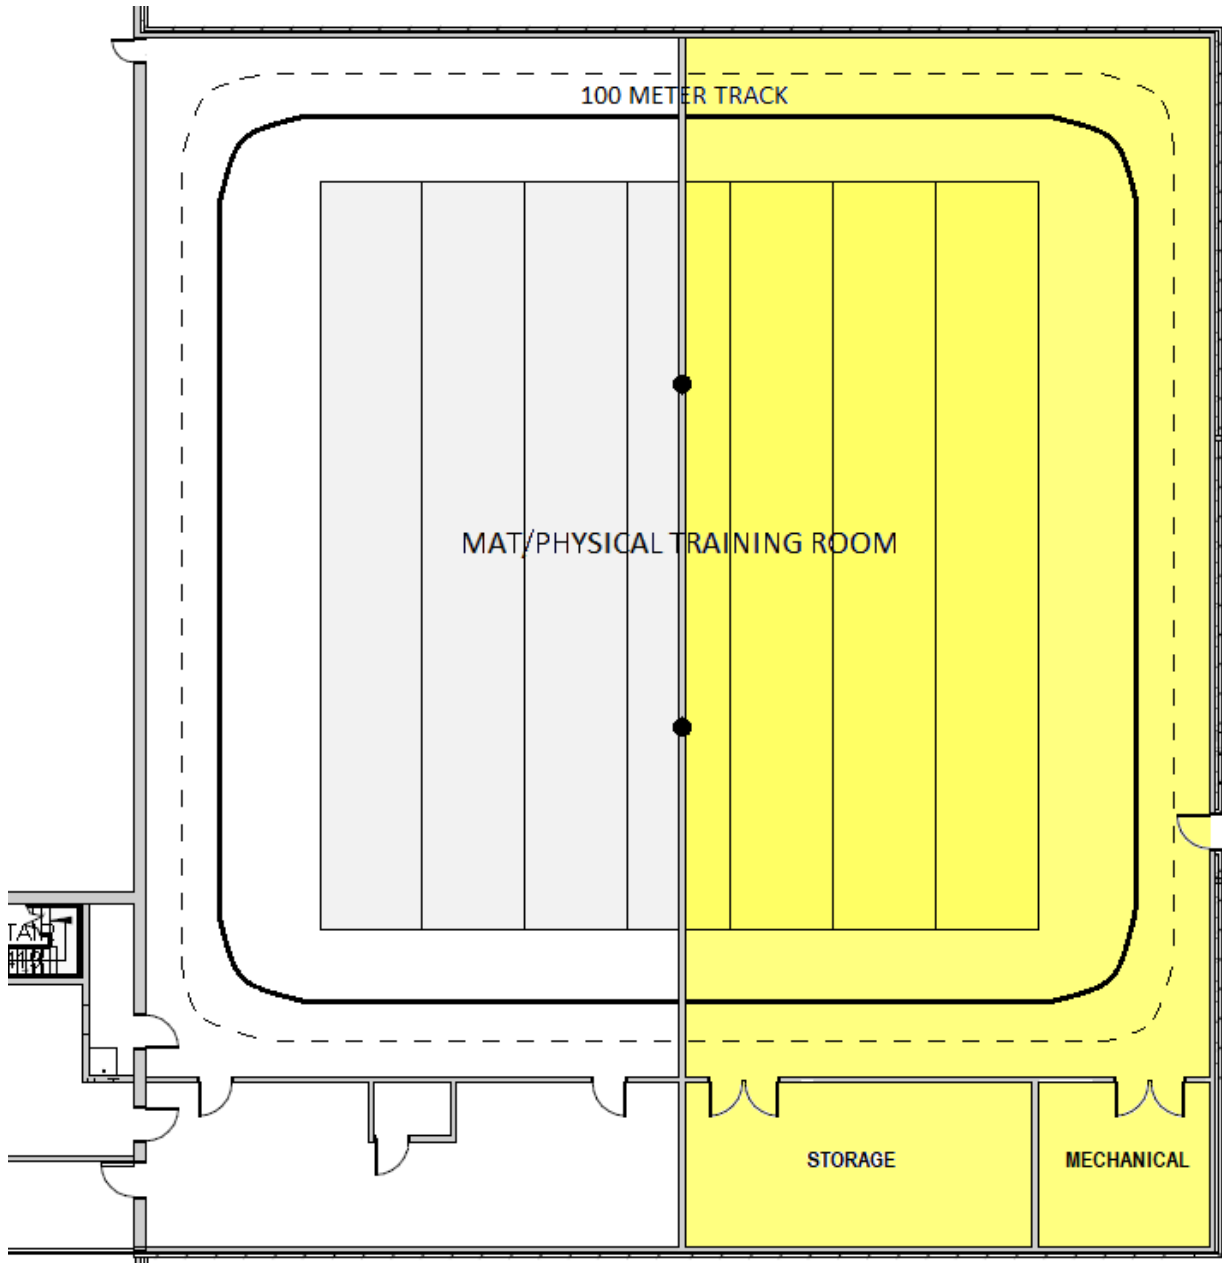
**PROPOSED INDOOR TRACK & MAT/TRAINING ROOM**

For years the Academy has utilized the gymnasium for this testing (and training), although larger class sizes over the past 10 years have forced us to find other locations. 40-50 people running on a 3 foot track around the outside of a basketball court is impossible to accomplish. Breaking the class up into 4-6 groups helps, but that extends the testing time greatly. Running tight corners repeatedly can create mechanical problems on knees and ankles, and maneuvering those corners with multiple officers at one time is a safety hazard (tripping, falling, and collision [with wall] injuries have been common). We've been using the outdoor track at the local High School (when weather permits) and one of the indoor arenas at the WY State Fairgrounds (when it doesn't), but regularly we are forced back into our gym due to scheduling conflicts with these facilities. Run scores are obviously better on a longer track with less (no) 90 degree turns; this inconsistency between locations has yet to be challenged. We are proposing that if/when the Indoor Range were to be moved to a new location, we then double the size of this area and create an indoor fitness area, to include a 100 meter track around a large mat area for custody and control training and other practical exercises. We could then do *all* of our PT Assessments onsite (consistency), and conduct physical fitness training, custody & control, and various practical skills training in this area. (See proposed design below)

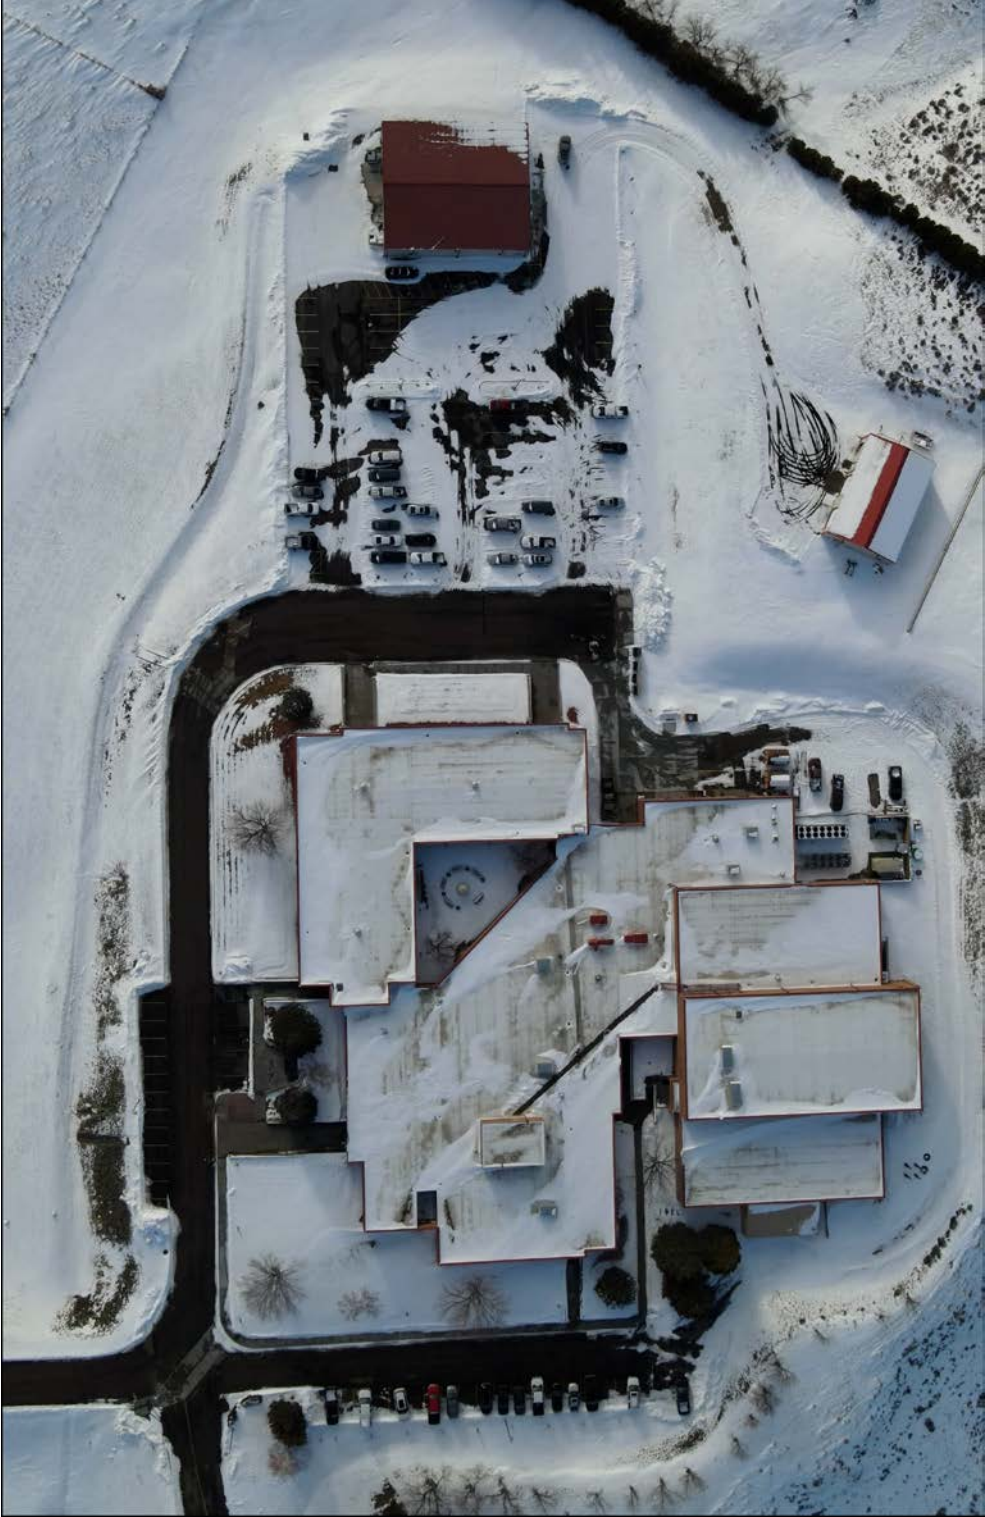
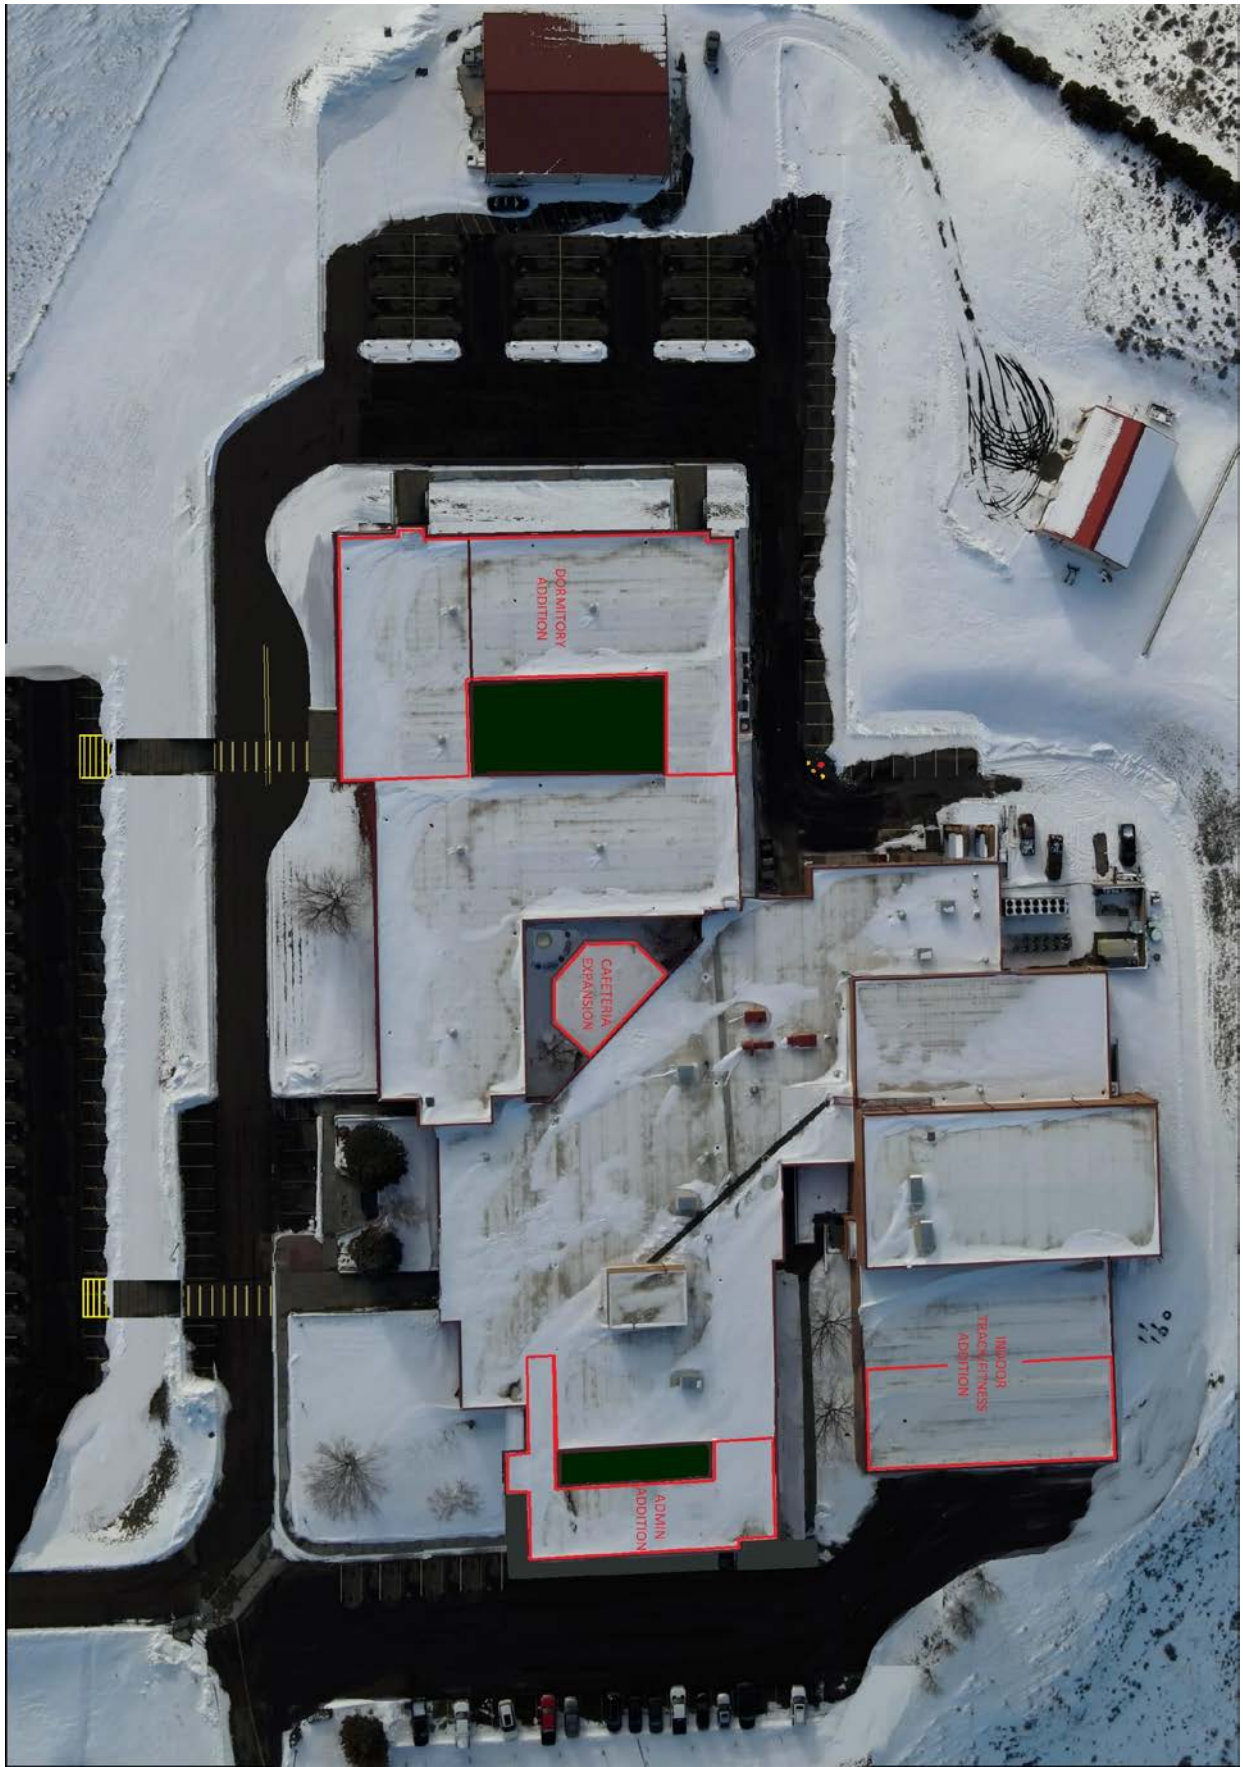
The following photos are an aerial photo taken of the WLEA (upper facilities). The top is the original, the bottom is digitally created. The bottom photo depicts a “rough” description of the location of each of the additions/expansions (in red) on the existing footprint, as well as the expanded/additional parking. Hopefully this will help you understand the physical impact to our site.

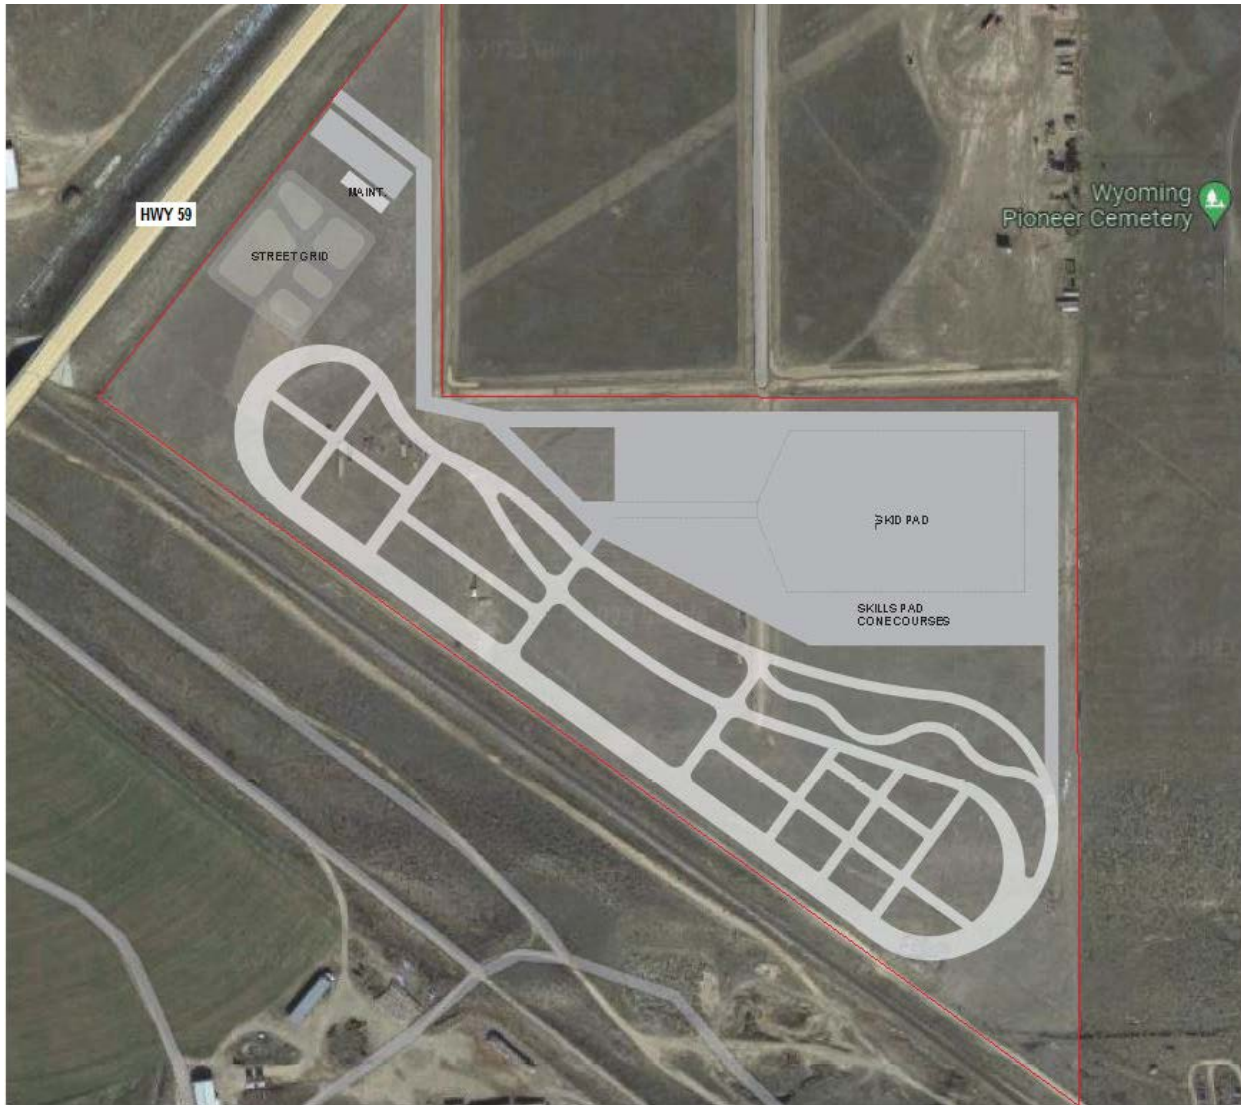
**PROPOSED PROPERTY / EVO COMPLEX (1 mile from WLEA on HWY 59)**

To rebuild the EVO pad - on the limited acreage, with the soil and drainage issues, as well as the current slope of the pad - seems like more of an investment than its worth. Instead, we feel moving the pad to a property where less subgrade work is necessary and more could be accomplished for the cost. A landowner with 39 acres of flat land across the river (boundaries are 500 yards apart) has verbally agreed to sell the property to the State. It's in an industrial area just off of Hwy 59 on the other side of (next to) the railroad tracks. This property would be ideal for a rebuild and expansion of the current driving pad. Our EVO facilities are insufficient for current training standards in Law Enforcement at this time. Being flat, further away from town and in an industrial area, would allow for greater use with little impact on the citizens of Douglas. At 39 acres (100% useable land), this property has three times the functional space as the entire current Academy grounds (which has 55 acres). The engineer who was involved in the recent Firearms Ranges Level I/II Study is also a leading designer in Emergency Vehicle Operations Training facilities for law enforcement. They included a draft EVO Complex for us on the 39 acres which met current standards for EVO training. It would include a building for vehicle and equipment storage, asphalt skid pad, asphalt skills pad (cone courses), asphalt street grid, and asphalt oval ¼ mile track with 500 yard straight away. This oval track would have multiple roadways, both gravel and asphalt, inside and out to help simulate various different road designs and ingress/egress onto the track and training pads. (See Proposed Land/EVO Complex below)

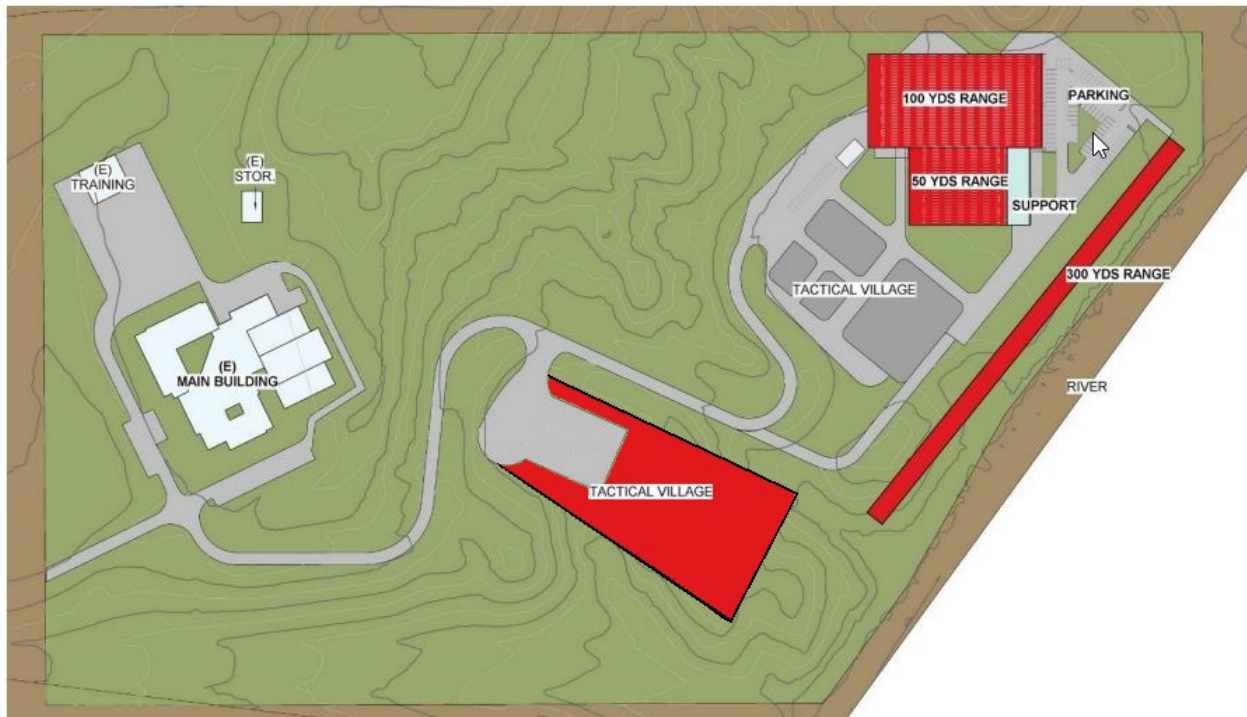
Common at most law enforcement training facilities is a “training city” or “tactical village” where officers are able to respond to calls at various different locations within a mock community. These “towns” have streets, store-fronts, residential areas, schools, and playgrounds. Although not full-size, the buildings that comprise this miniature town resemble “real-life” businesses, schools, and residences where officers respond to domestic violence calls, DUI’s, bar fights, robberies, and traffic violations. Hypothetical training in a sterile classroom is unrealistic and ineffective, and repeated building searches or traffic stops performed on the same dormitory or in the same parking lot limit an officer’s ability to focus and prepare for the many unknowns they’ll meet. To move the Emergency Vehicle Operations training, and place the Firearms ranges on the Current EVO Pad (as is the recommendation from the Level I/II study), would free up several acres of already “established” property with two fully equipped buildings - bathrooms, electricity, heat, etc. ([previously] Outdoor Handgun Range House and EVO Garage). The [previous] Handgun Range House could serve as a staging area for those awaiting training, while the EVO Garage/Tower could double as a gas station and observation point for instructional staff dispatching officers to various calls in the WLEA Tactical Village. Asphalt roadways are already established and “alternative” structures could be constructed to resemble a small village located at the Outdoor Range facilities, and on the EVO Pad. A considerable amount of dirt could be moved from the current outdoor range berm/backstop to provide for additional space for this village. (See proposal below)

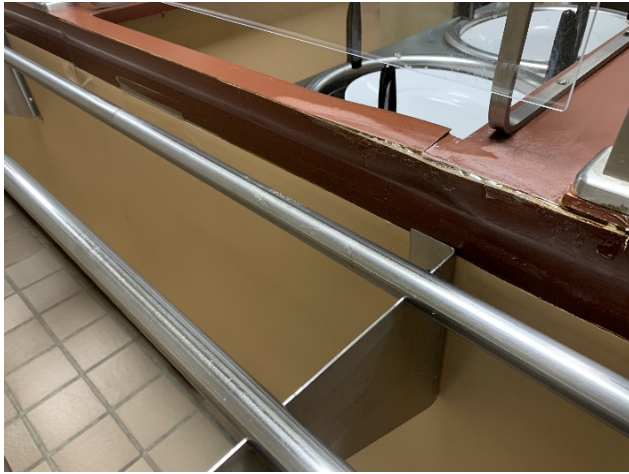
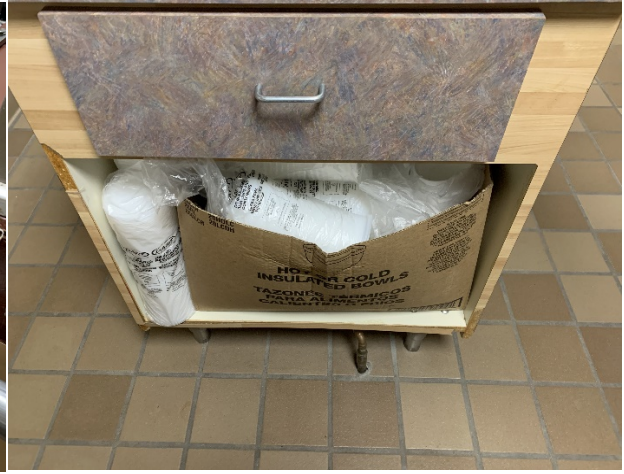
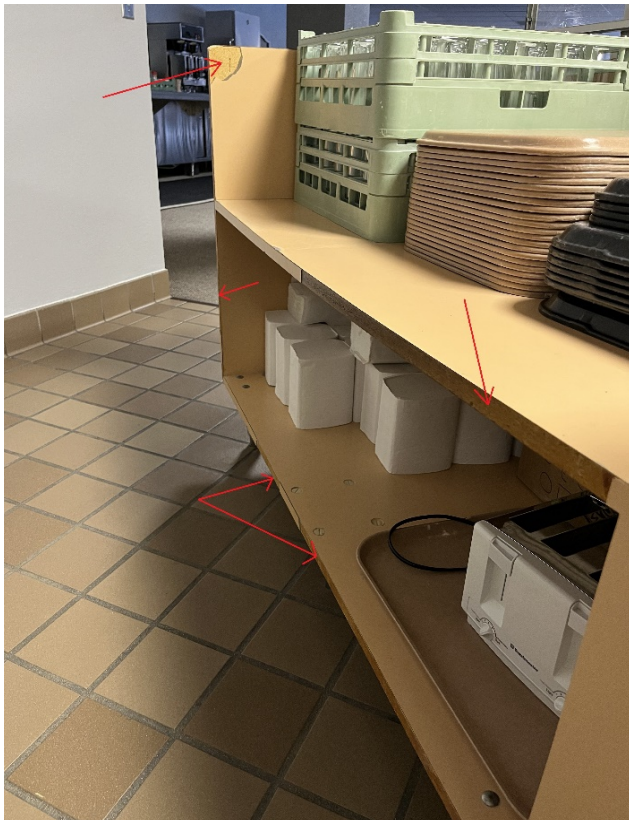
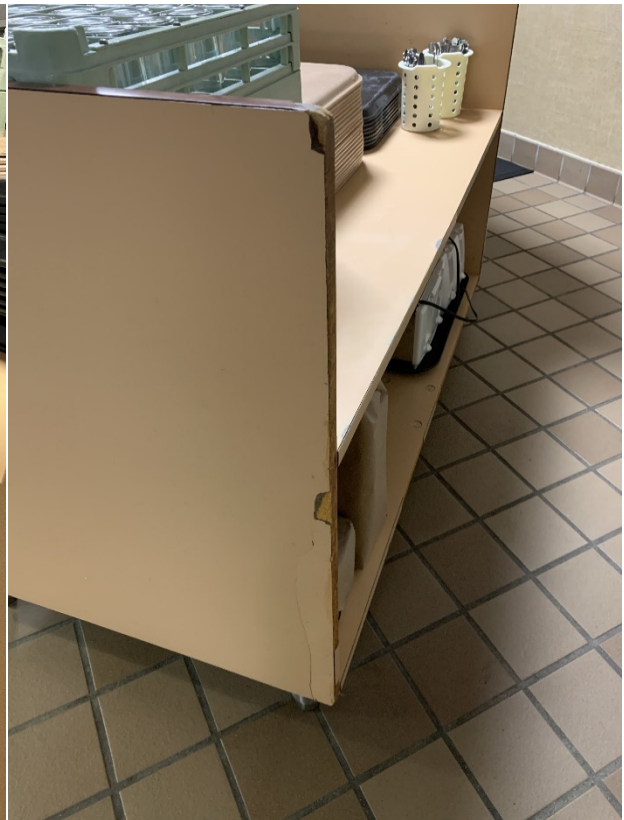
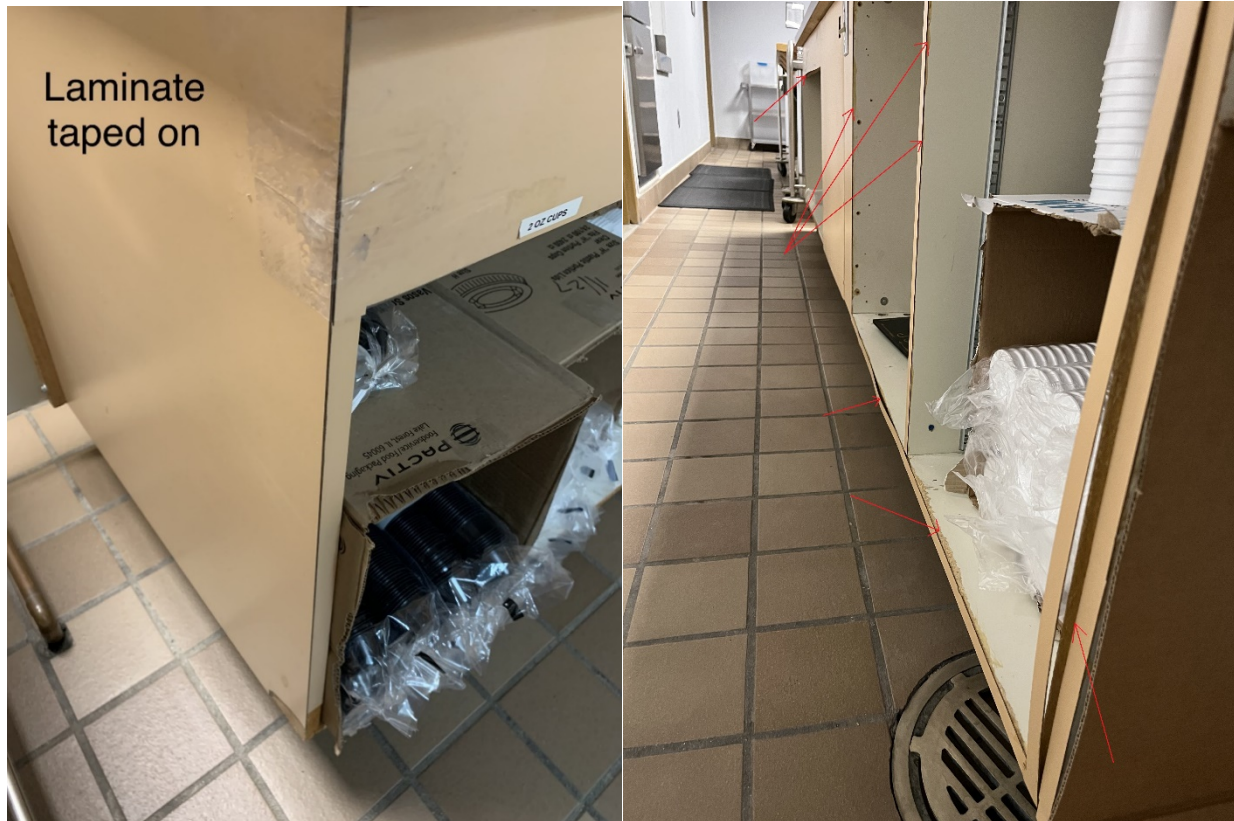
The cafeteria serving line has been operational for 40 years. It has become a sanitation hazard and eyesore in an otherwise immaculate area. Laminate has peeled off, broken, and chipped allowing water to saturate the particle wood top. This has caused swelling of the wood resulting in further separation. Porous surfaces are difficult to keep clean, which creates an added hazard on equipment that is used to serve and store food items. The staff serve thousands of meals to students each year, open for virtually every meal Monday through Friday. The food service section is in dire need of a complete replacement of our serving line to maintain health and safety of the food they provide. (See pictures below) **This was included with the 2023 Major Maintenance Requests.**

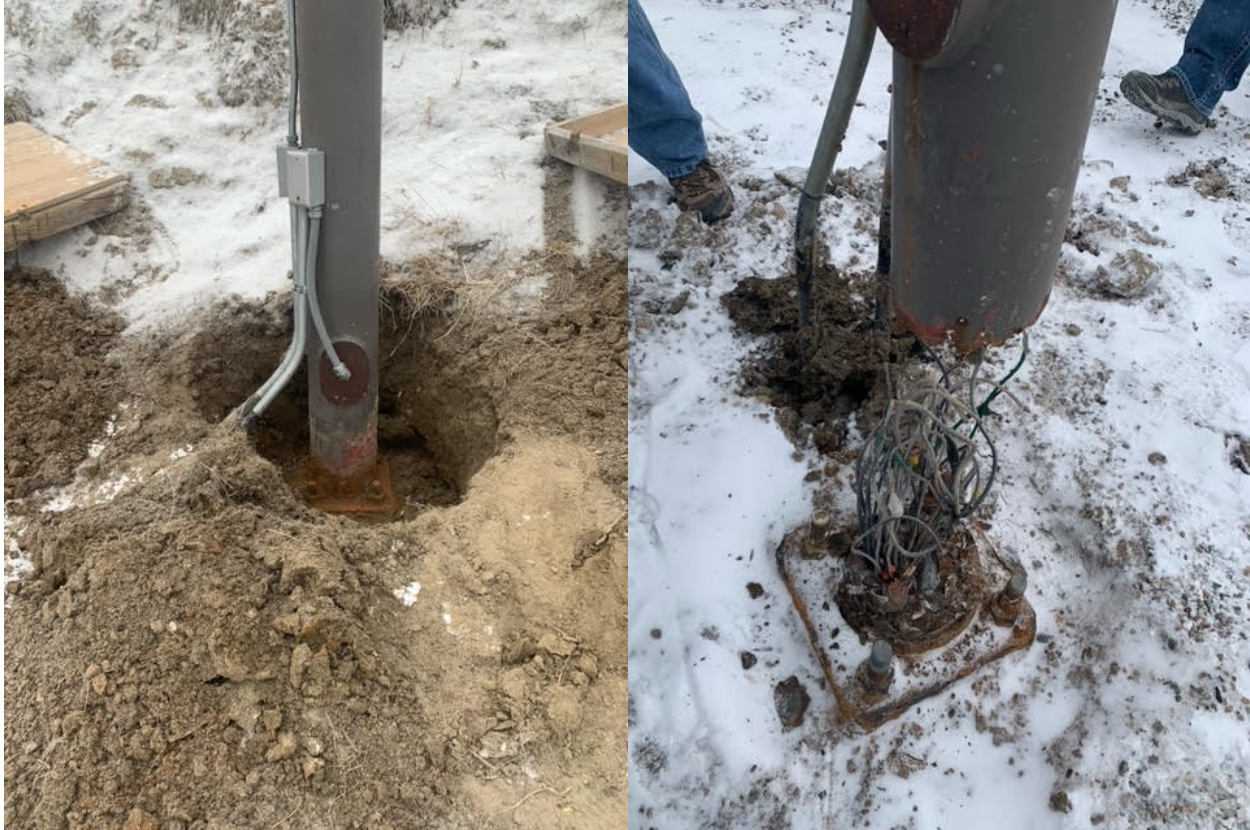
Last winter we had a light pole in the parking lot of the Outdoor Range break at the bottom, nearly falling onto the firearms range. We found that debris over the years had covered up the base of the pole, causing it to rust, impacting the integrity of the steel. After inspecting the other light poles on campus, we discovered similar issues with several of them (rust causing decreased strength, electrical access doors covered where wires shorted out, decayed grout at flange connections, etc.). As with much of the WLEA facilities, these poles are original from 40 years ago and have exceeded their life expectancy. Replacement of these lights and poles are necessary to ensure facility safety and assist in after-hours security surveillance. Four poles have been removed from our Emergency Vehicle Operation driving pad, but there are eleven (11) others in need of replacement. (See pictures below) **This was included with the 2023 Major Maintenance Requests.**

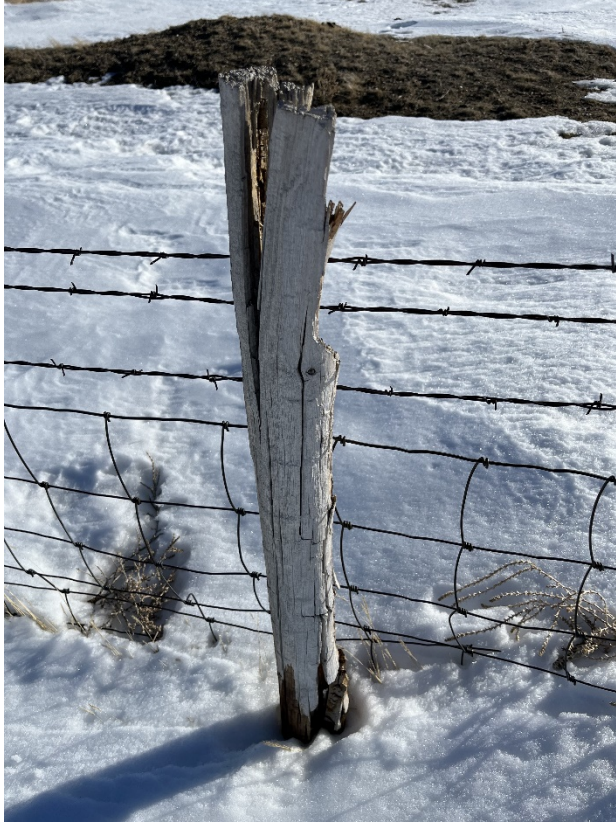
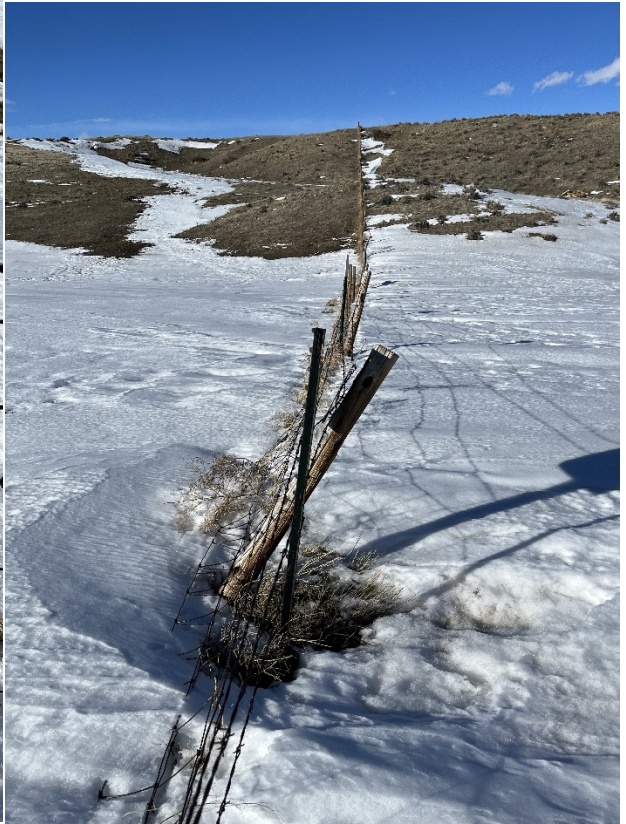
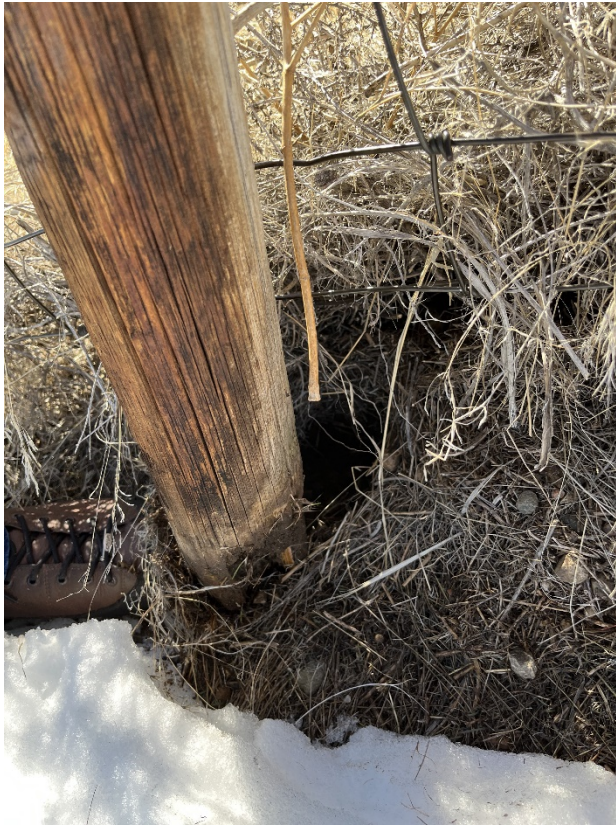
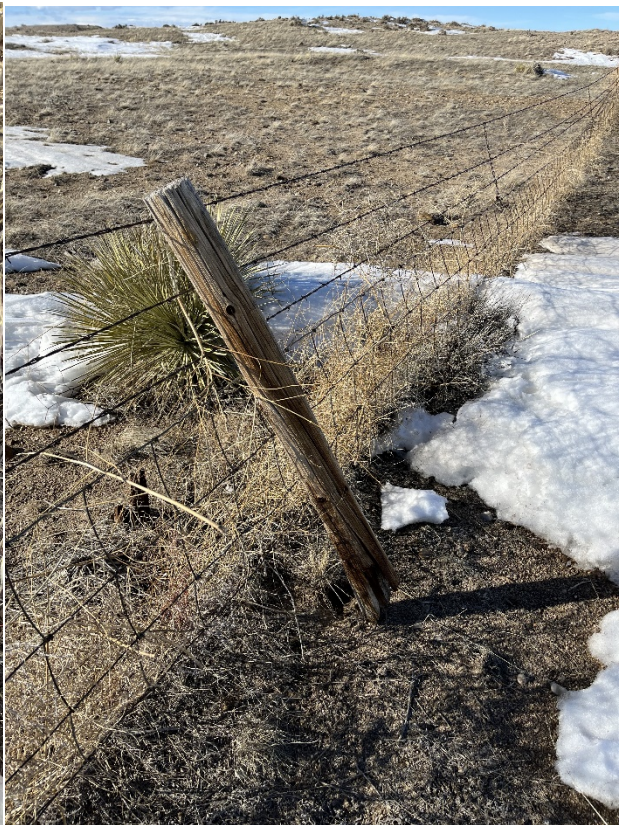
There are currently dozens of wood posts that are rotted off at ground level after 35+ years. The fence has fallen down in several areas and we have had to go in and prop the fence back up with steel posts to keep the neighboring livestock out of our property; this spring we will need to go in and drive posts to support multiple large sections that have fallen or don't have standing posts any longer. The right of way fencing along the WLEA property along Hwy 59 was replaced in 2022 through a WYDOT Hwy 59 asphalt project, but there is still roughly 1 mile of fencing that is in need of replacement separating us from our two neighbors. (See pictures below) **This was included with the 2023 Major Maintenance Requests.**

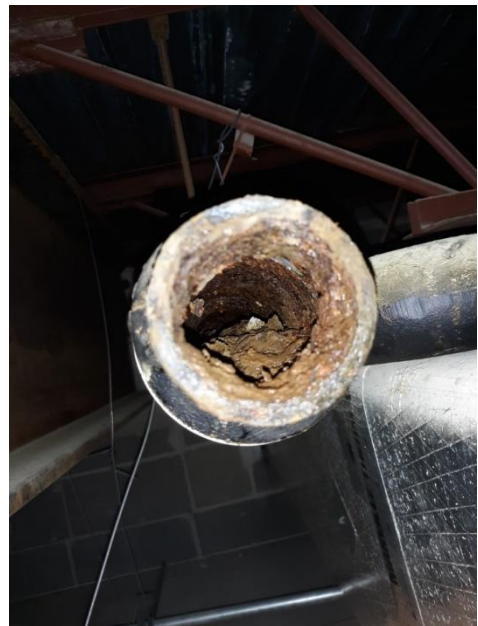
We have experienced a number of emergency situations that dealt with the Academy's drain lines. We regularly experience flooding in the housekeeping room as the industrial washing machine drains into a trough/floor drain which is corroded with rust and debris. When this happens, our housekeeping area becomes covered in water and we have to snake the drain. We had another major drain failure in 2020 when a rubber boot/coupling vibrated off of a 3" HVAC water line in a mechanical room, flooding the room. Because of a restricted floor drain, glycol water overflowed and dumped into the hallway below. The drain pipes throughout the roughly 82,000 sq. ft. of main building are cast iron. We had to replace 150 foot of these drain lines (above ceiling) in 2021 due to a leak. When we opened up the line to determine the problem we found that much of the 3" line was over 75% clogged. After running a camera down the wall and into the floor drain, we discovered it

too was 30% clogged as well. We've since discovered multiple floor drains throughout the facility that were nearly corroded shut. Although part of our preventative maintenance plan is to pour water down these drains monthly, the amount of water we were pouring down has not kept the pipes clean, but in fact likely added to the rust deposit that has been taking place inside. As a result, we have had to spend considerable time snaking out these lines (as best we could) to try and clear these out in the event these floor drains were needed in an emergency. We suspect that in the very near future we could continue to see corrosion that impacts the integrity of these drain pipes (above ceiling and below ground/floors) causing collapse, leaks, back-ups, and flooding - resulting in property damage. Replacement of these pipes would prove costly and have a tremendous impact on the operation of this facility and mission of this agency, but knowing the current condition of this system would give us the ability to better attack this pending crisis. **This was included with the 2023 Major Maintenance Requests.**

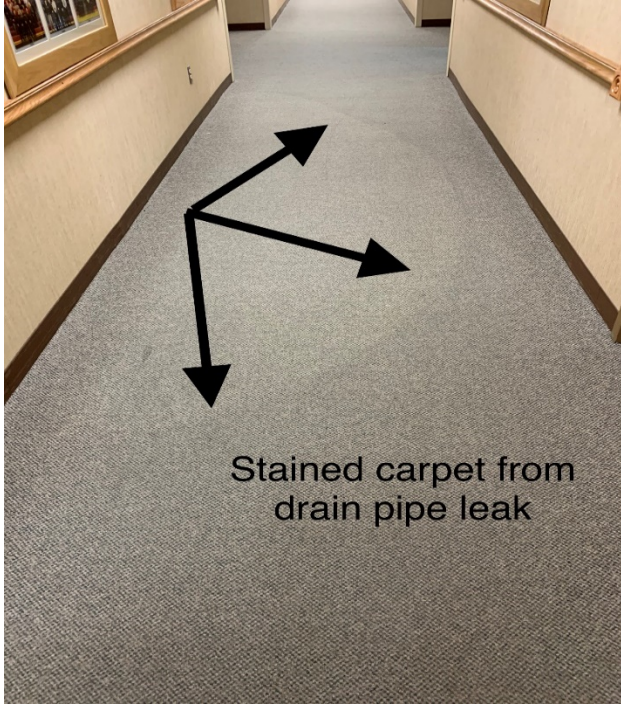
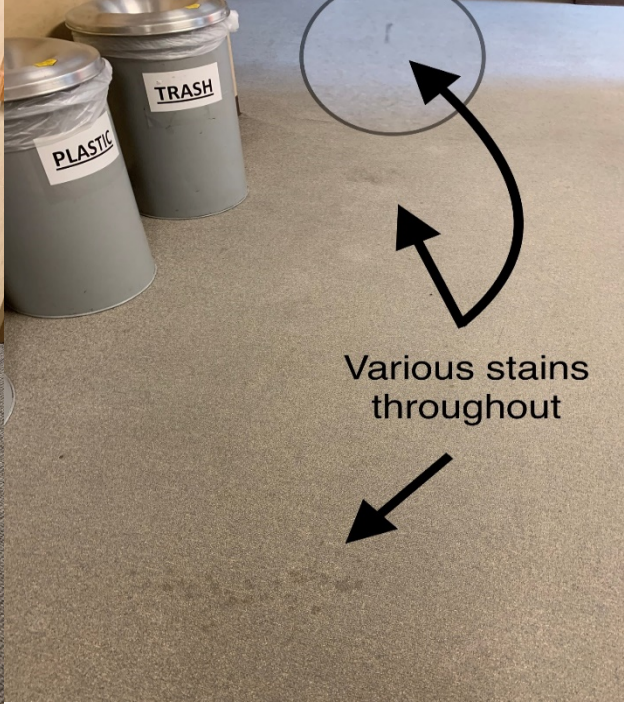
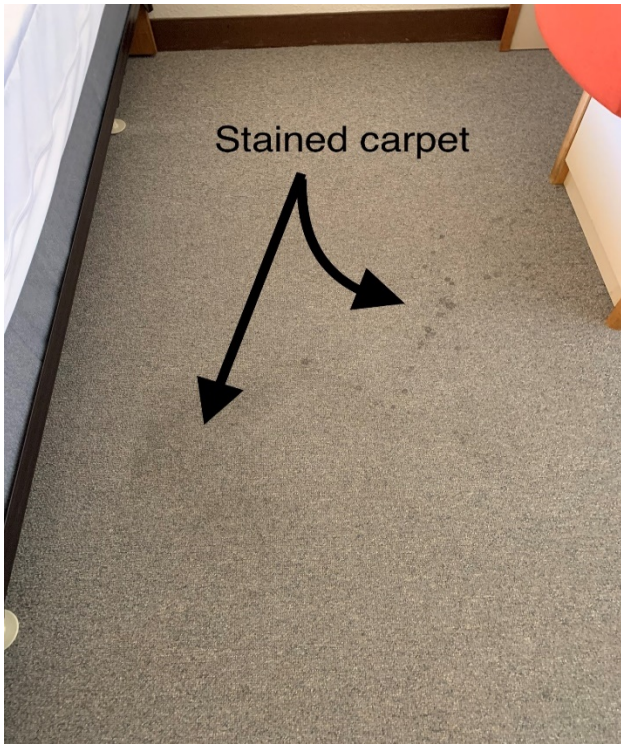
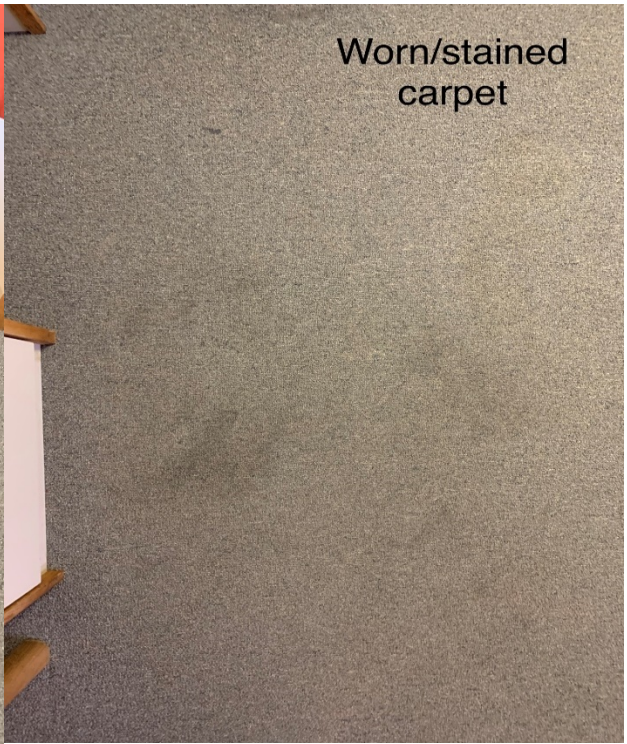
In 2018 we were allocated \$40,000 for carpet replacement. We were able to complete some minor flooring repairs, but nothing substantial was accomplished with that amount. In 2020 we asked for \$100,000 additional monies and it was denied. The carpet is worn, stained, and badly in need of replacement throughout much of the facility. (See pictures below) **We were allocated \$120,000 in Major Maintenance monies in 2022 to address this need. This should allow us to address major hallways within the facility.**
