# Wyoming Law Enforcement Academy

## Condition & Recommendation Report - 2023

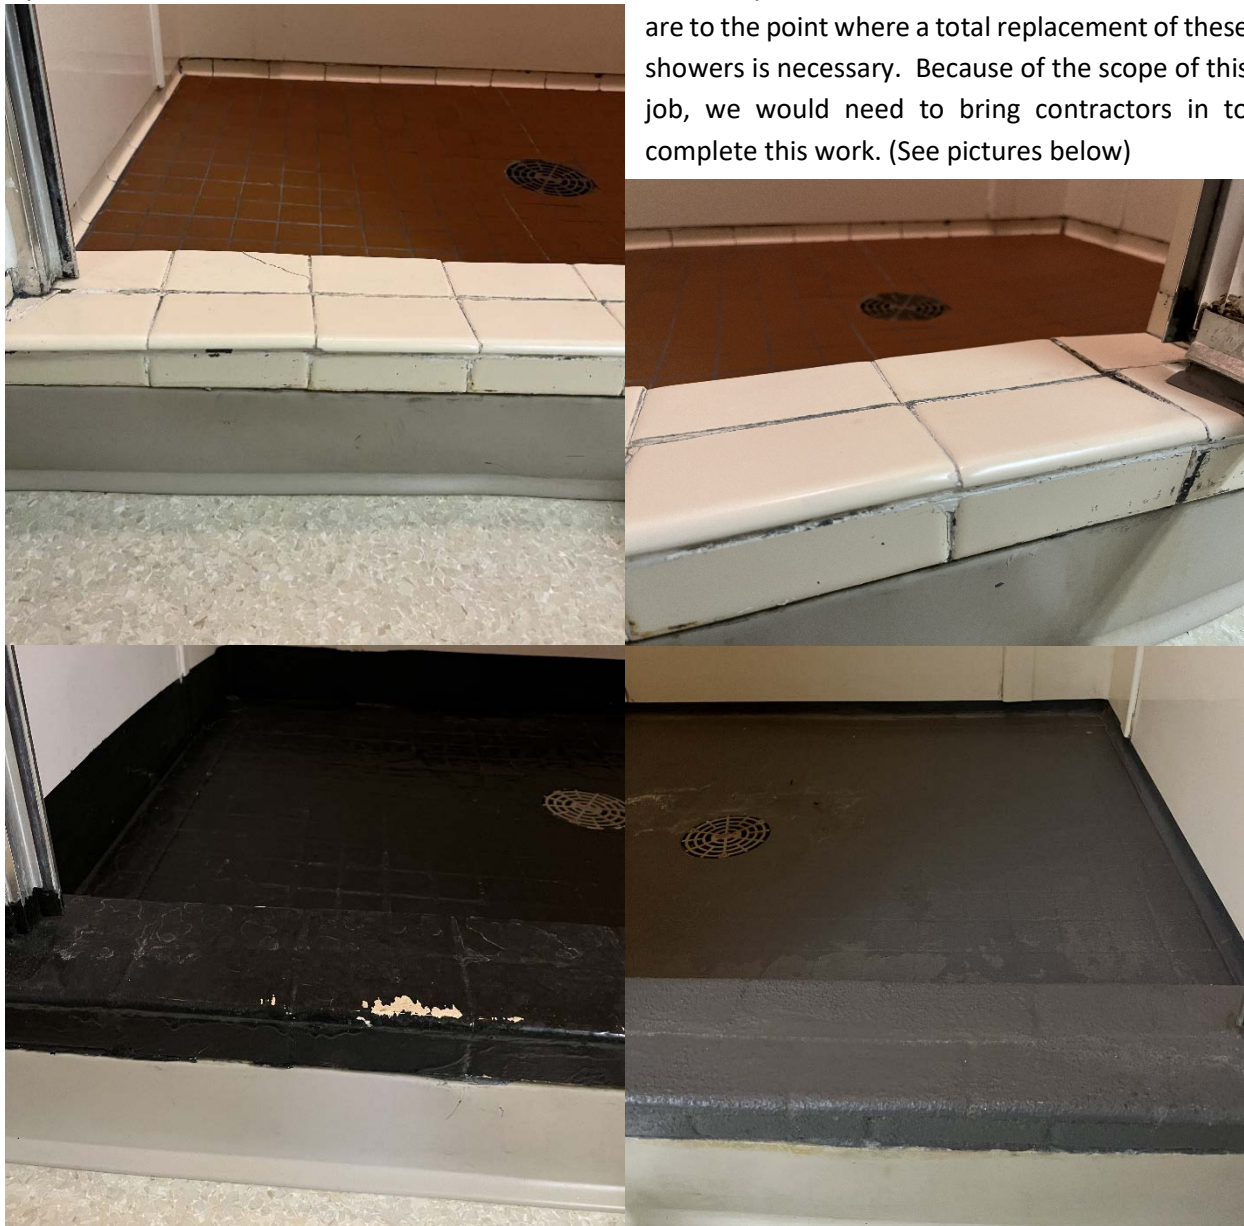
Each of the 60 dorm rooms have a shower unit. These showers are constructed of paneling with a custom tile drain-pan. Over the years these shower units have sprung leaks between paneling, where the paneling meets the drain-pan, and in the drain-pan itself. Staff have replaced caulking, grout, drain-pans, and used various sealcoats on the pan (Rhino Liner, Flex Seal, etc.), but to no avail. Roughly once a month we have reports from students or staff who observe water in our hallways or on the floors of the dorm room. We

are to the point where a total replacement of these showers is necessary. Because of the scope of this job, we would need to bring contractors in to complete this work. (See pictures below)

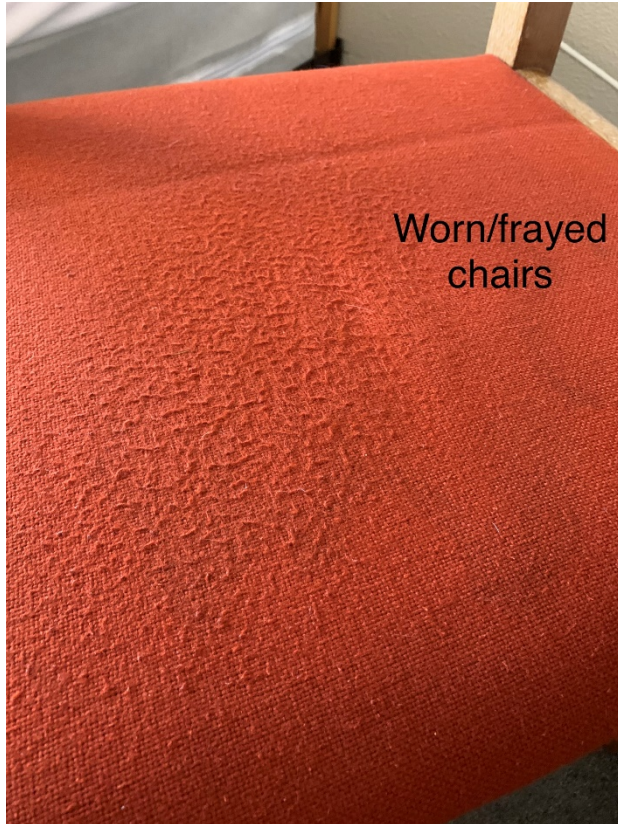
All of the furniture in our dorm rooms and dayrooms are original (excluding mattresses). There are two wooden upholstered desk chairs in each room; material is stained, worn, or torn, and wood joints are cracked, broken, or loose. We also have one cushioned chair in each room; these are stained/worn out. There are two desks, two armoires, a headboard, and one night stand in each room. Some of the problems we have with these are: wood finish faded, surfaces are damaged, chipped and pealed laminate, cracked doors/hinges, doors/drawers out of alignment, broken drawers/rollers, etc. We've been out of extra/spare furniture for years, which were used as parts. We need a total replacement of all furniture to improve the atmosphere here, minimize maintenance issues, and aid in keeping these items sanitized. (See pictures below)

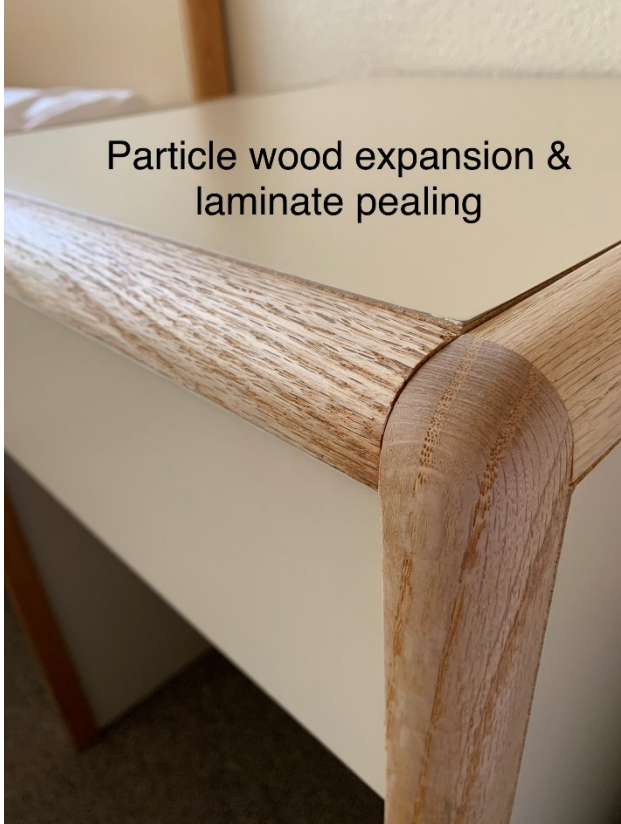
Particle wood expansion & laminate peeling

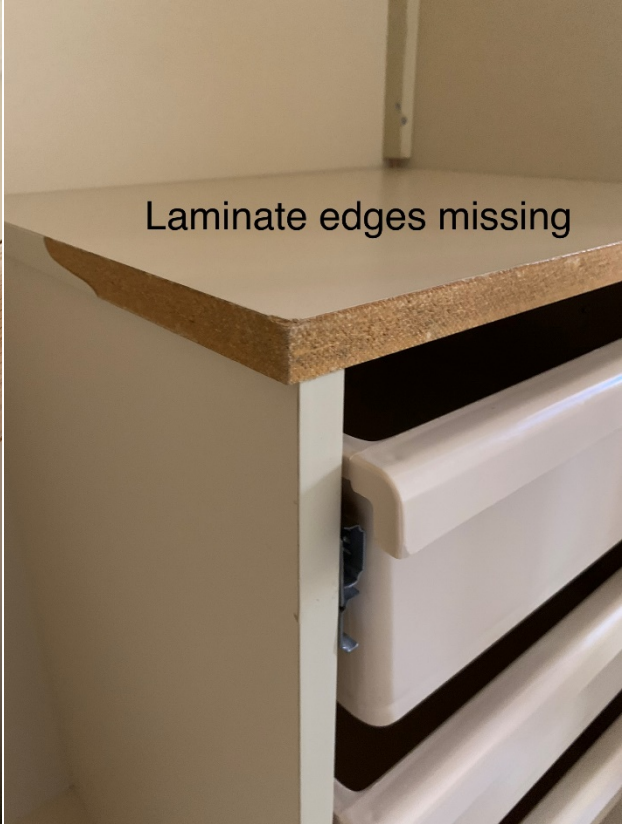
Laminate edges missing

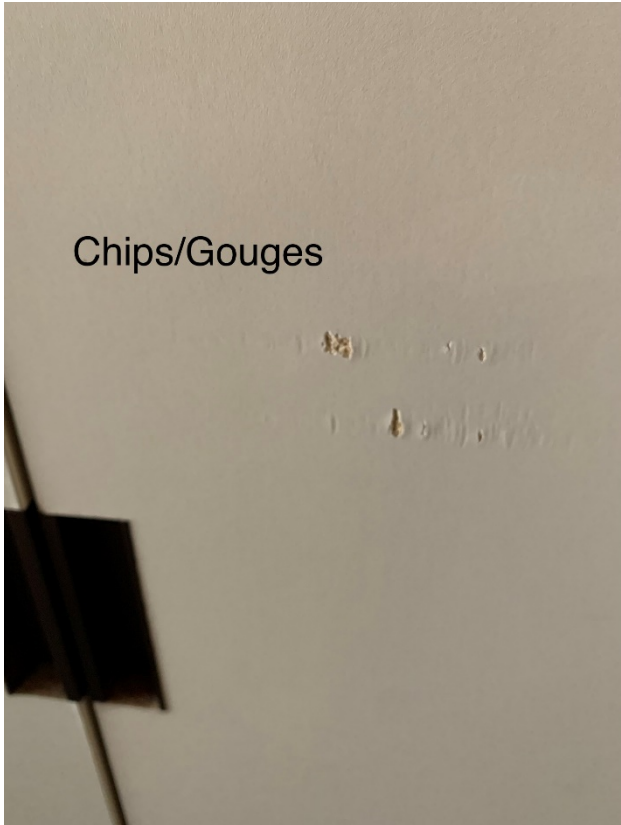
Chips/Gouges

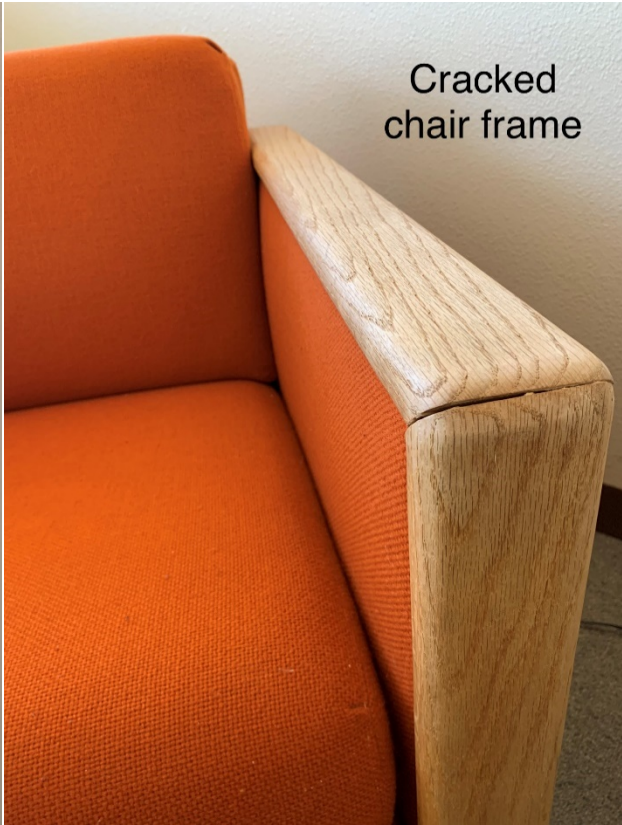
Cracked chair frame

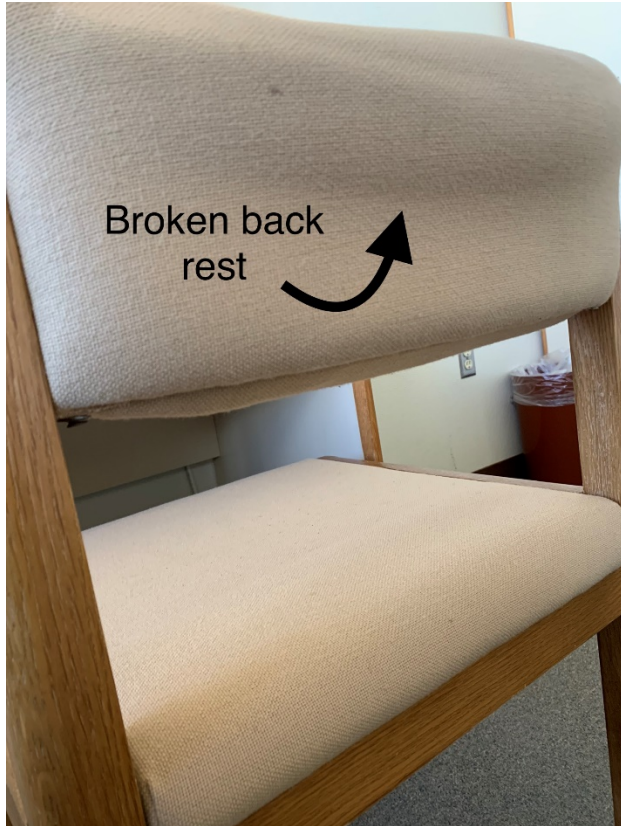
Broken back rest

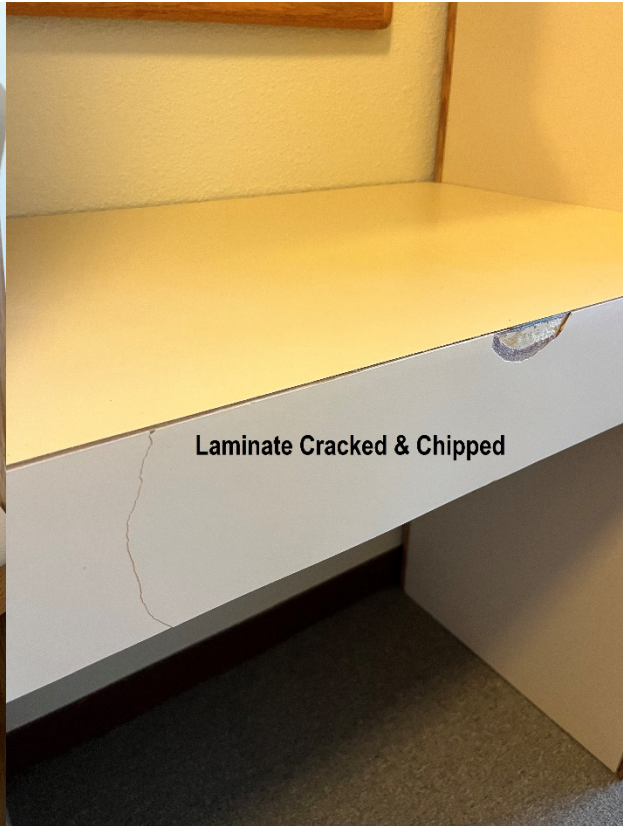
Laminate Cracked & Chipped

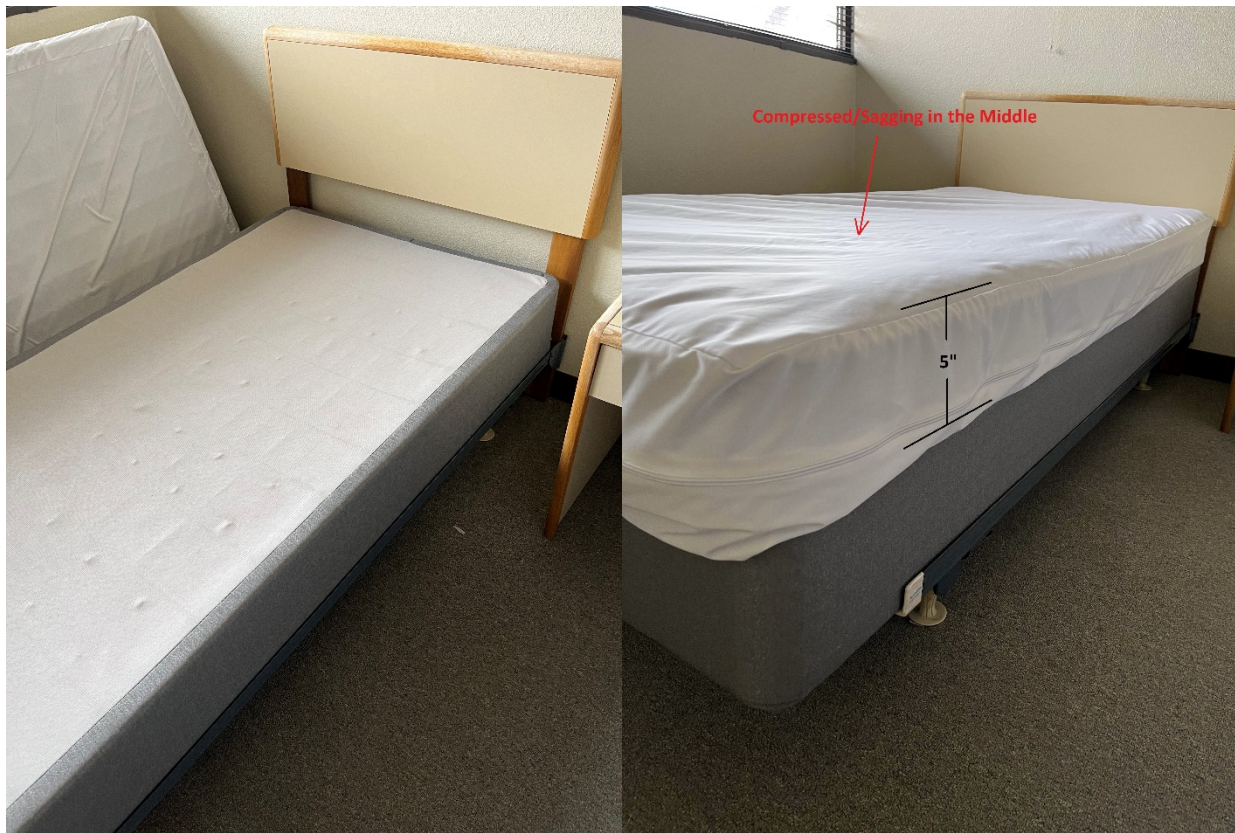
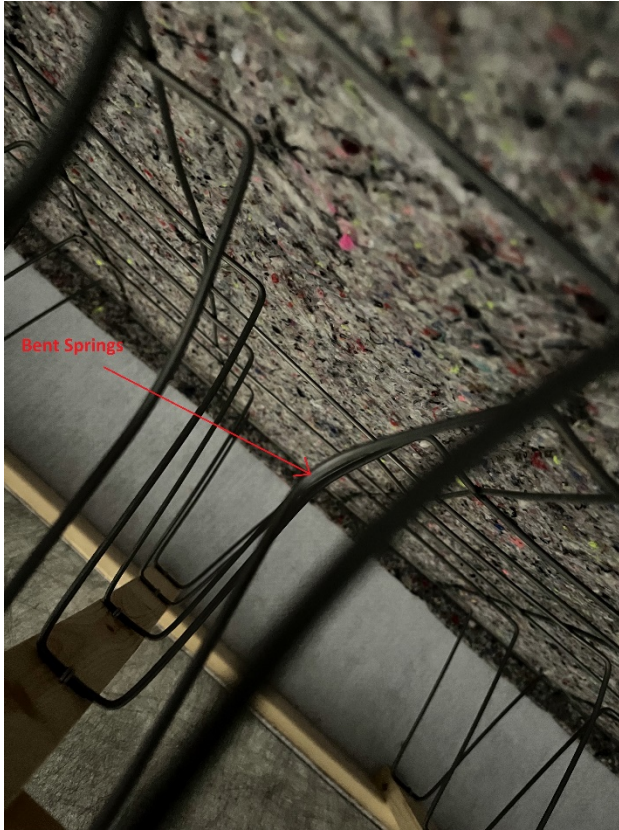
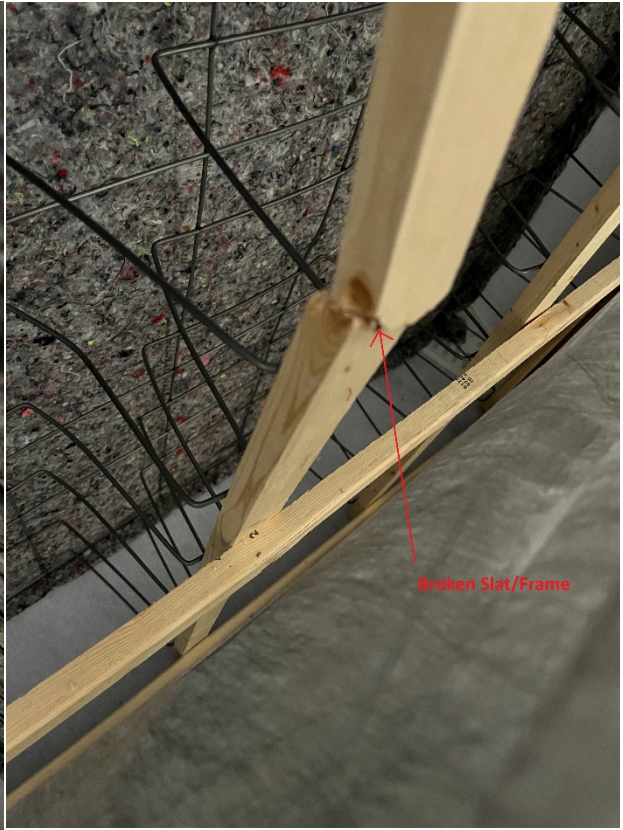
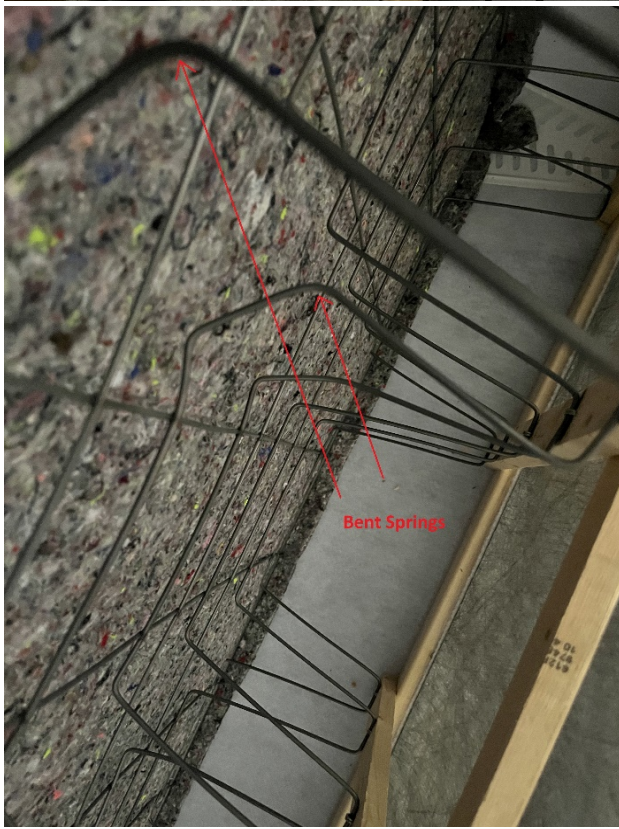
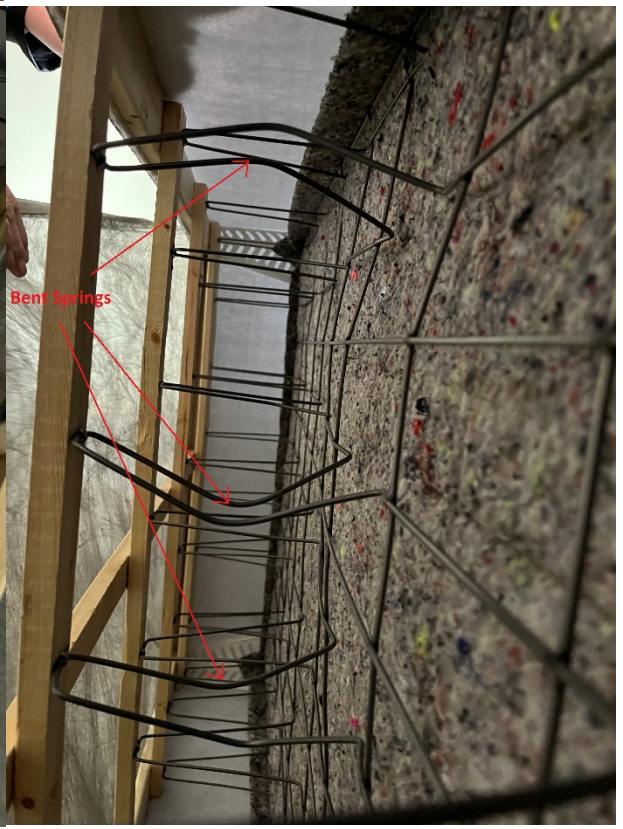
In 2015 the Academy purchased new mattresses and box springs to replace all of the beds (112) in the dormitory. At the time, the box springs selected were constructed of 1" X 2" wood frames, which saved the State a considerable amount of money – *at the time*. We have had to replace 8-10 annually and staff recently checked the condition of all of the box springs throughout the dormitory and found 27 that were broken or badly damaged; three needed to be immediately replaced. Many had broken slats, yet the integrity of the box spring had not been severely compromised. Further inspection has revealed that most of the mattresses had multiple wires (springs) that were bent and deformed from years of use. The inexpensive construction and light materials used has made them susceptible to breaking when adults (some large) set on the side of these twin bed; they were likely built with children in mind. The mattresses are also in need of replacement after nearly a decade of constant use. These too, were inexpensive comparatively when purchased, therefore they have broken down considerably and should be replaced. (See pictures below)

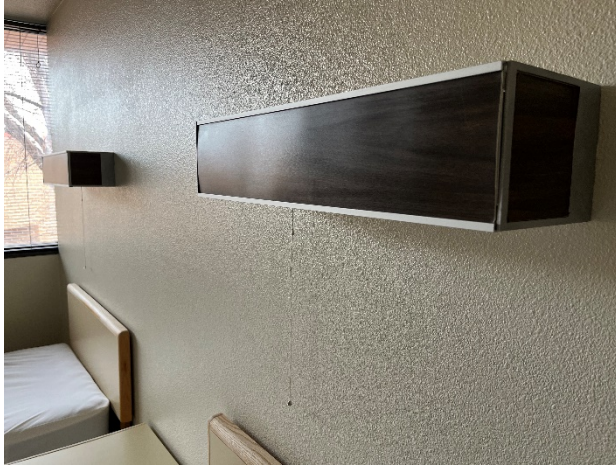
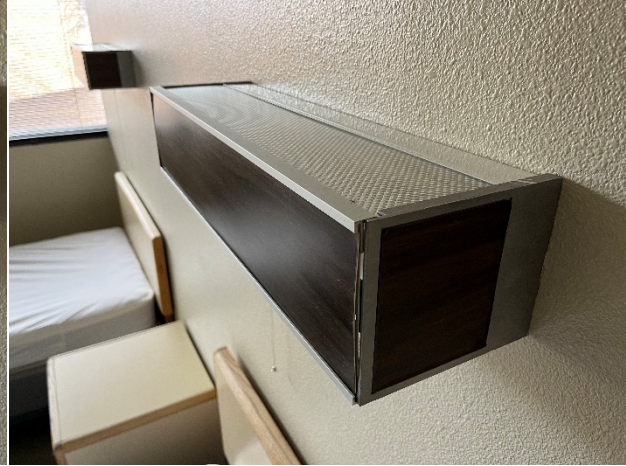
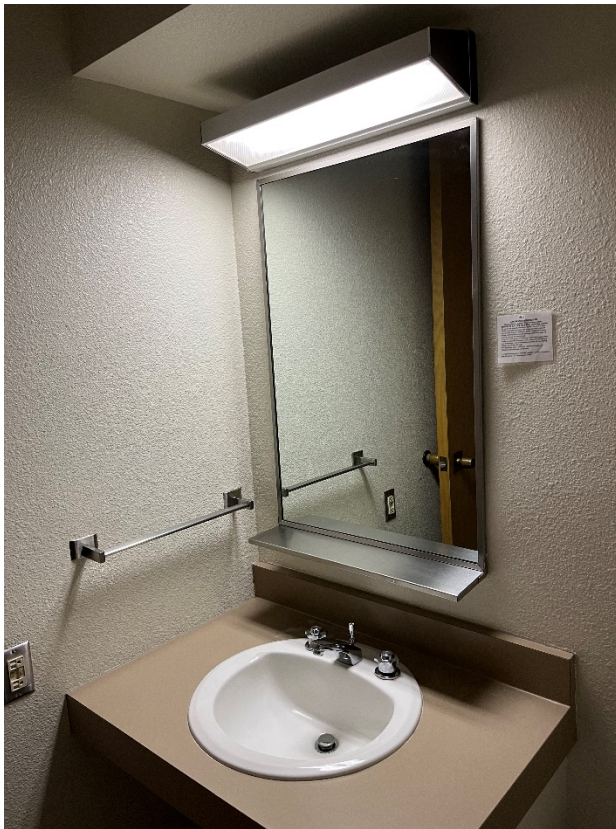
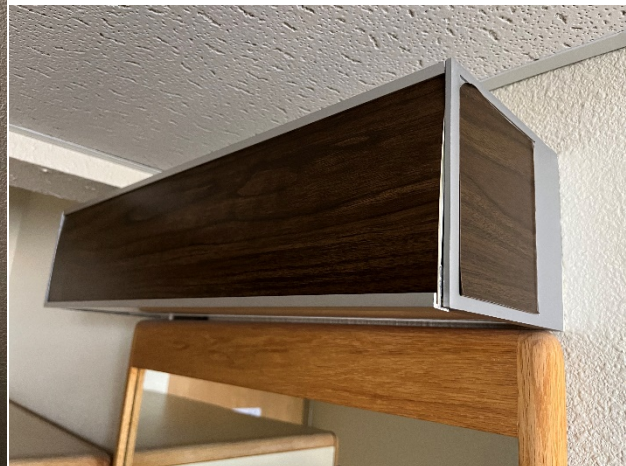
Many of the wall lights in the dorm rooms and dorm bathrooms have had to be replaced due to age and failure. Staff has been replacing those with new fixtures and LED bulbs. These are much easier to maintain and provide a cost-savings to the State in electricity. These forty year-old fixtures will be needing completely replaced in the next 10 years. (See pictures below)
